Quality Assurance and Source Inspection

Contract #: 04-0120F4Cty: SF/ALA Rte: 80 PM: 13.2/13.9File #: 69.28**WELDING INSPECTION REPORT****Resident Engineer:**Siegenthaler, Peter**Address:** 333 Burma Road**City:** Oakland, CA 94607**Report No:** WIR-026094**Date Inspected:** 10-Jul-2011**Project Name:** SAS Superstructure**OSM Arrival Time:** 1900**Prime Contractor:** American Bridge/Fluor Enterprises, a JV**OSM Departure Time:** 700**Contractor:** Zhenhua Port Machinery Company, Ltd (ZPMC), Changxing Island **Location:** Shanghai, China**CWI Name:** See below**CWI Present:** Yes No**Inspected CWI report:** Yes No N/A**Rod Oven in Use:** Yes No N/A**Electrode to specification:** Yes No N/A**Weld Procedures Followed:** Yes No N/A**Qualified Welders:** Yes No N/A**Verified Joint Fit-up:** Yes No N/A**Approved Drawings:** Yes No N/A**Approved WPS:** Yes No N/A**Delayed / Cancelled:** Yes No N/A**Bridge No:** 34-0006**Component:** OBG**Summary of Items Observed:**

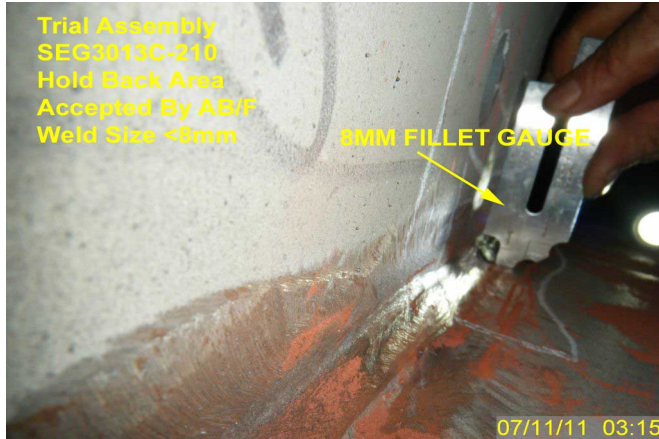
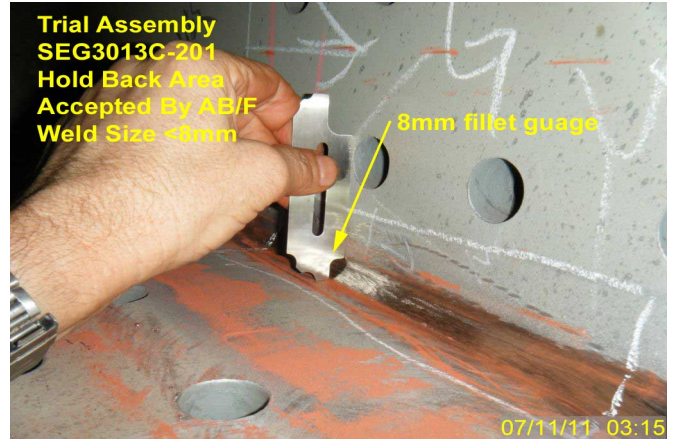
During random in-process visual inspection of welds located in OBG13E, this Quality Assurance Inspector (QA) observed under size welds in an area previously inspected and accepted by ZPMC and AB/F. This QA informed ZPMC QC Zhung Wei of this condition. The area is located on SEG3013C and identified as weld numbers 201, 206 and 226. A TL-015 Incident Report will be documented for the accordance. (See Photos below)
